MISCELLANEOUS PAPER NO. 4-704

BEHAVIOR OF EPOXY-ASPHALT AIRFIELD PAVEMENTS 1963 INSPECTIONS

February 1965

U. S. Army Engineer Waterways Experiment Station
CORPS OF ENGINEERS
Vicksburg, Mississippi

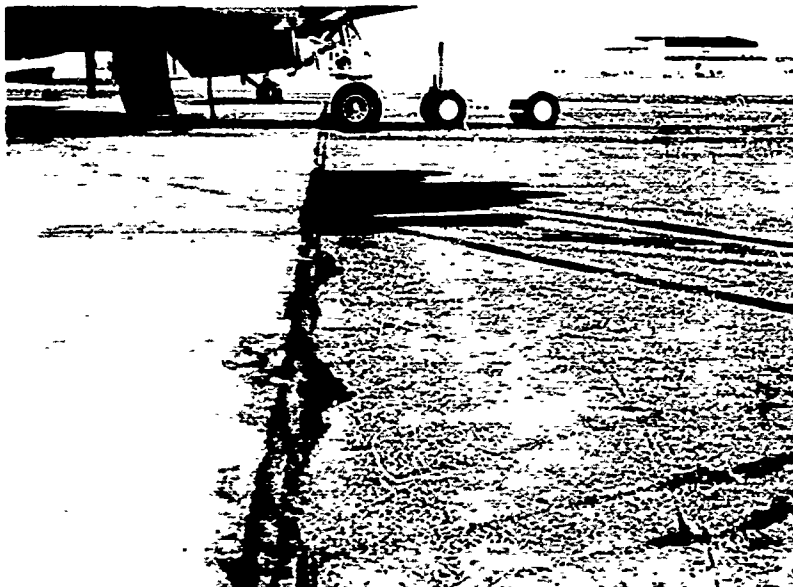
8. Condition of epoxy-asphalt pavement. Photographs 1-4 show the epoxy-asphalt pavement at Berry Field. The spillage has resulted in little or no apparent damage to the pavements. Examination of the surface did not reveal any softening. There was a small amount of shrinkage cracking in the longitudinal joints, which was most prevalent in the third joint from the south edge and the second joint from the north edge of each panel area. In spite of the spillage and the limited shrinkage cracking, the pavement as a whole was in excellent condition. The surface texture was good, and the joints were exceptionally smooth and well formed. Only time will tell whether the spilled fluids will enter the shrinkage cracks and damage the underlying asphaltic concrete. At the time of the inspection, oil appeared to be seeping into only one crack.

Photograph 1. Berry Field. Edge of overlay pavement. Note proximity of joint in original pavement

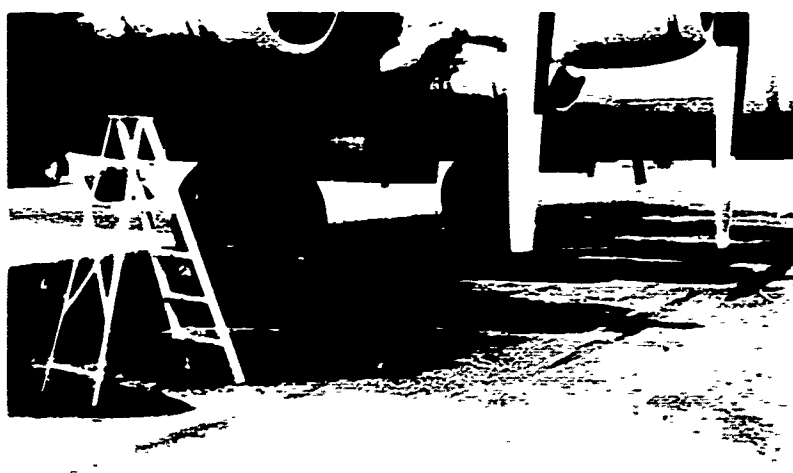
Photograph 2. Berry Field. Oil spillage occurring during maintenance operations

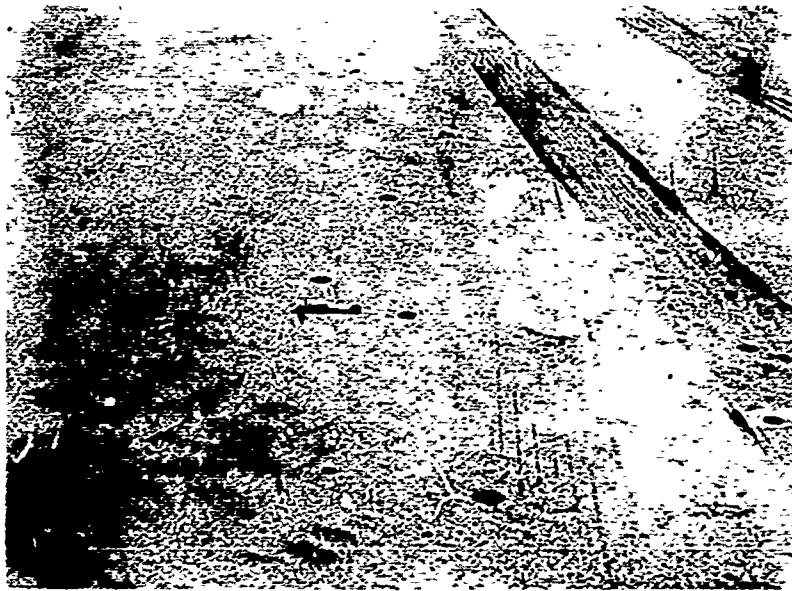
Photograph 3. Berry Field. Surface texture at longitudinal joint in epoxy-asphalt overlay

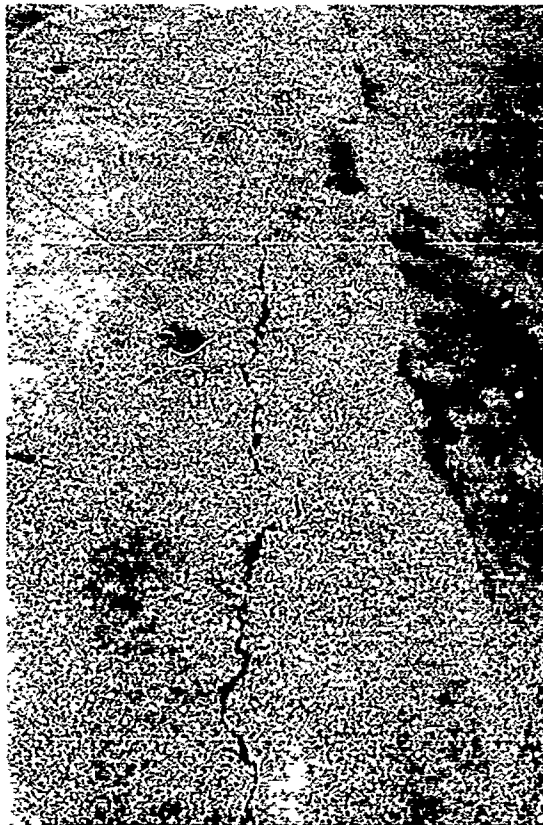
19. Description. The epoxy-asphalt pavement at Perrin AFB consisted of 10,500 sq yd of overlay 3/4 to 1 in. thick placed over an asphalt-surfaced parking area for refueling trucks. The overlay was constructed in September 1962 using type II binder. The then-existing surface of the parking area was in generally poor condition. Only extremely unsatisfactory portions were repaired before the epoxy-asphalt overlay was placed; therefore, there were extensive areas of fuel-saturated pavement and areas exhibiting deterioration from other causes. Photograph 17, taken at one edge of the overlay, shows the condition of the original pavement.

Photograph 17. Perrin AFB. Edge of epoxy-asphalt overlay showing condition of underlying pavement

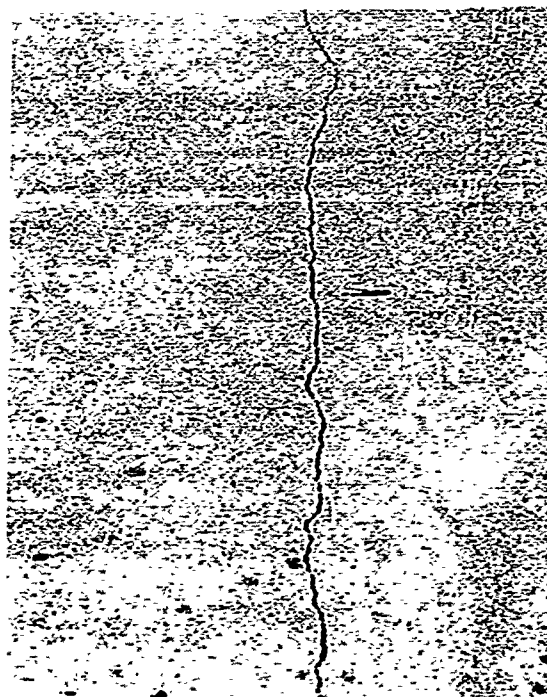
Photograph 25. Davis-Monthan
AFB. Shrinkage crack in epoxy-
asphalt pavement

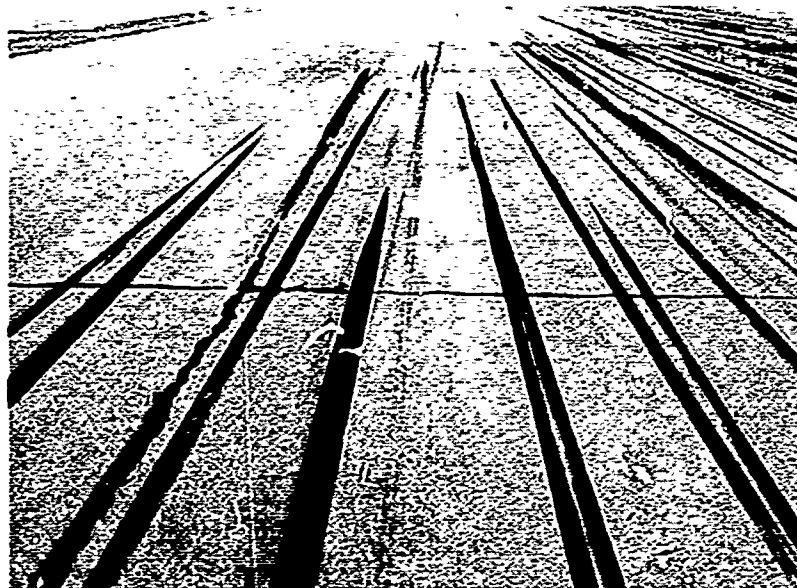
31. Condition of epoxy-asphalt pavement. Reflection cracking had occurred over the portland cement concrete joints on the northeast end of the runway. Occasional small shrinkage cracking, as can be seen in photographs 26 and 27, had also developed. Attempts at filling the cracks with an epoxy-asphalt emulsion, as seen in photograph 28, had not been successful. Reflection cracking also occurred on the southwest end of the runway, as shown in photographs 29 and 30. An area free of cracking is shown in photograph 31.

Photograph 27. George AFB. Reflection cracks which had been sealed

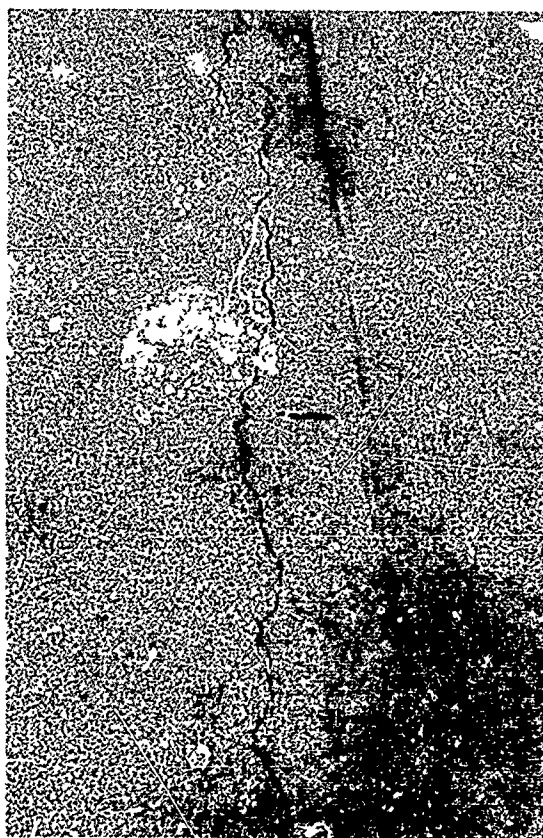
35. Condition of epoxy-asphalt pavement. There were a number of reflection cracks at joints in the old pavement and a few random cracks which appeared to be from shrinkage. The presence of these cracks was another reason that the pavement had remained closed to traffic, as the Base Civil Engineer wanted to repair them while the pavement was still clean and the cracks were free from debris which would be worked into them by traffic. The epoxy-asphalt overlay is shown in photographs 33-36.

Photograph 36. Stead AFB. Random shrinkage crack in epoxy-asphalt overlay

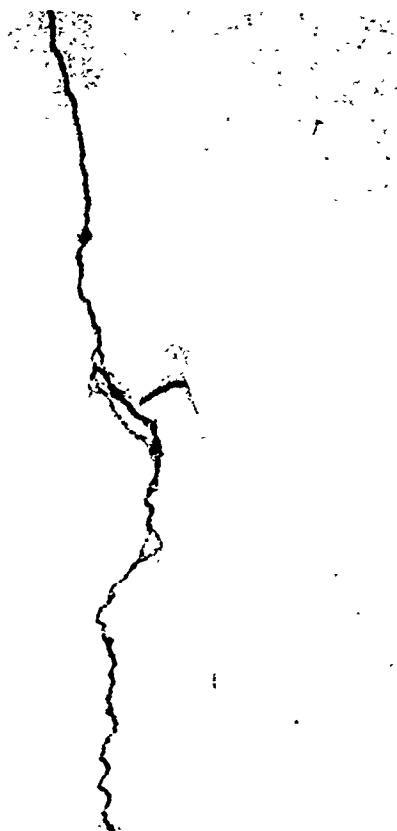
Photograph 39. Reno ANG Field.
Random shrinkage crack. In center
of photograph is fragment of loose
epoxy-asphalt overlay

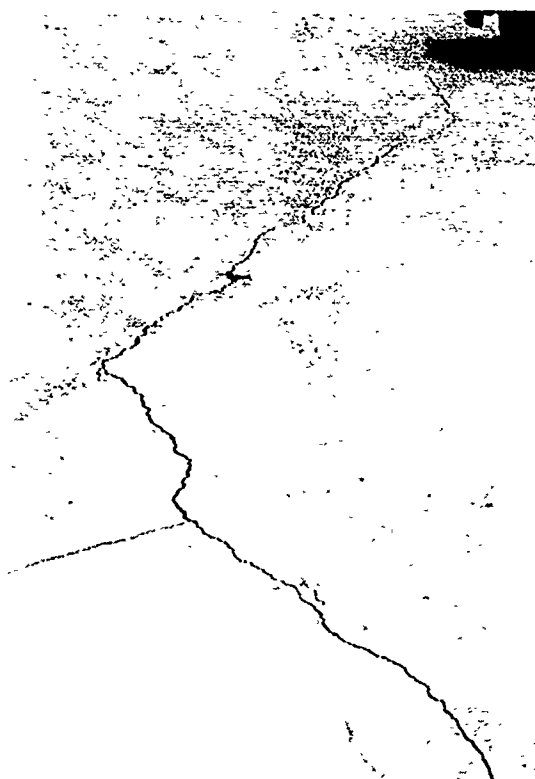
Photograph 40. Reno ANG Field.
Close-up showing fragment of
pavement broken out of epoxy-
asphalt overlay

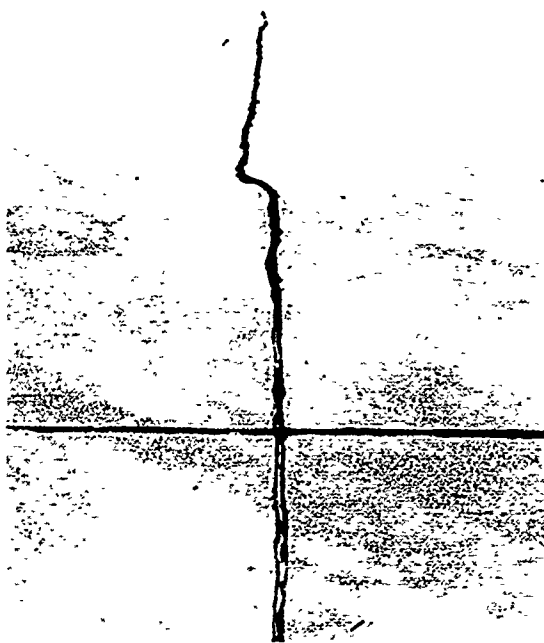
Photograph 42. Seymour Johnson AFB.
Cracks that have been routed and
sealed with epoxy asphalt

52. Maintenance. Some of the cracks were routed and sealed with joint-sealer material during the spring of 1963, as shown in photograph 42. Four different types of joint sealers were used, two cold-applied and two hot-applied. The hot-applied sealers were SS-164 and SS-167. Both of these sealers appeared to be properly bonded to the pavement, and the joints were sealed at the time of inspection. The cold-applied sealers (SS-170 and SS-200A) did not adhere to the epoxy asphalt, and were considered unsatisfactory. Prior to the inspection, the Shell Oil Company had sent two 5-gal cans of a rubberized-tar emulsion to Seymour Johnson AFB for experiments in sealing the reflection cracks. Several cracks were

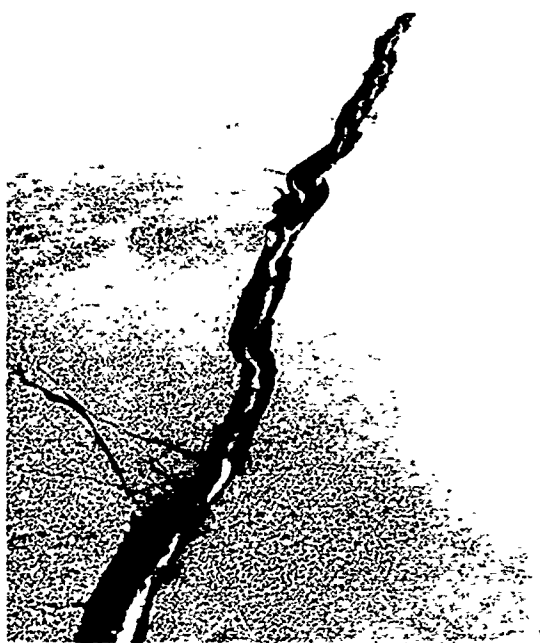
Photograph 43. Seymour Johnson AFB.
Crack sealed with emulsion

sealed with this material during the inspection on 1 May 1963. The crack shown in the lower right of photograph 44 was sealed by squeegeeing the emulsion into the crack. The crack on the left of the photograph was sealed by diluting the emulsion with water and pouring it into the crack. The emulsion broke quite rapidly and shrunk down in the crack. The base personnel were planning to refill this crack the following day and also to do further experimenting in filling the cracks. A close-up of the emulsion squeegeed into the crack is shown in photograph 43.

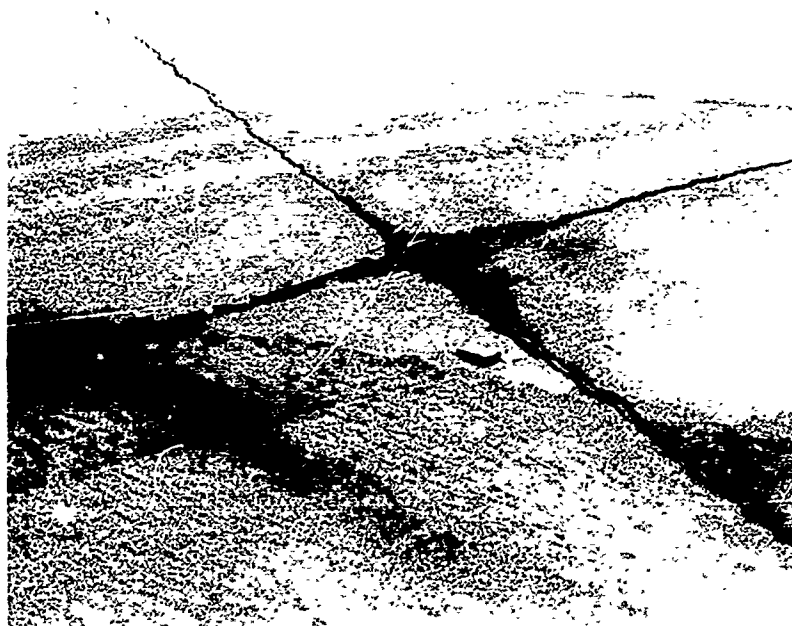
Photograph 44. Seymour Johnson AFB. Cracks in epoxy-
asphalt pavement. Note joint-filling material in
cracks in foreground

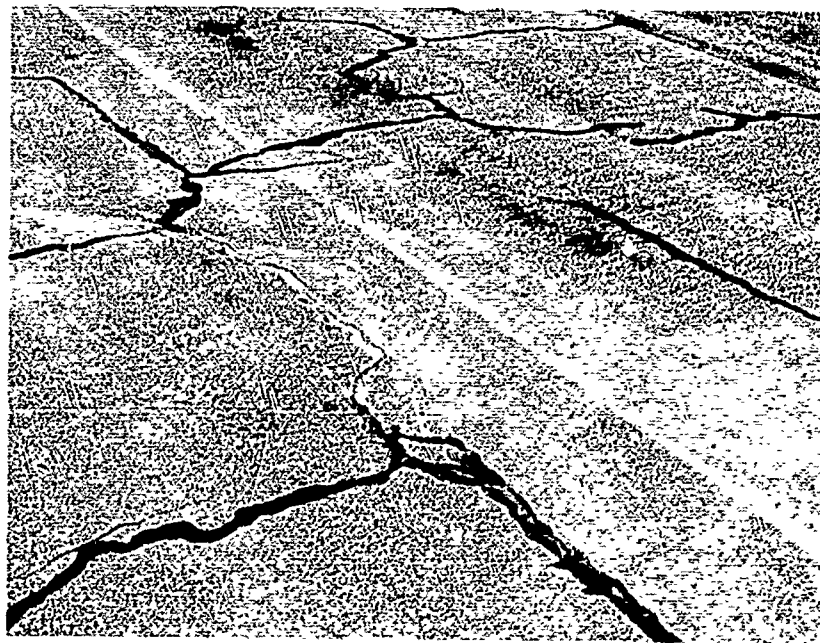
71. Condition of epoxy-asphalt pavement. The epoxy-asphalt pavement at Westchester County Airport had cracked more extensively than any other epoxy-asphalt pavement observed. It is possible that the thinness of the pavement (1/2 in. thick) and the poor construction procedures contributed to this extensive cracking. Photographs 63 and 64 show the type of cracking that has occurred.

Photograph 63. Westchester County Airport. Typical cracking in epoxy-asphalt pavement

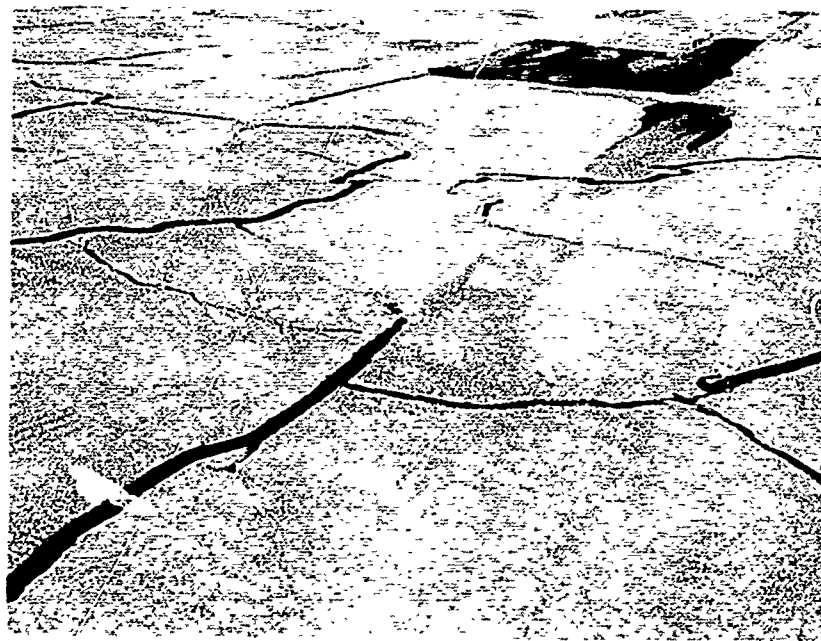
Photograph 64. Westchester County Airport. Cracking pattern on epoxy-asphalt pavements with patches in background
